Introductions to
Heritage Assets

Water Meadows

September 2013

ENGLISH HERITAGE

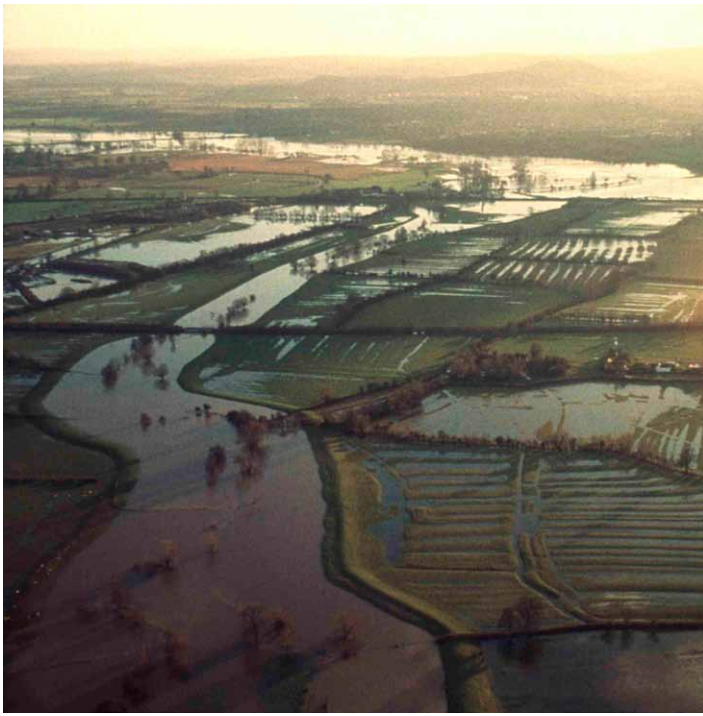
Fig 1. Water meadow earthworks on the River Lugg, Herefordshire, picked out by floodwater.

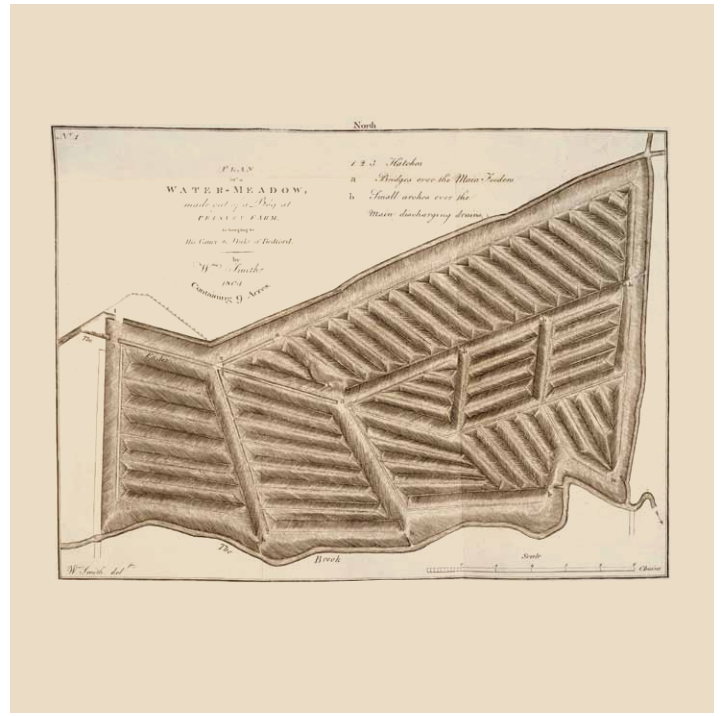
Fig 2. At Prisleys Farm, Bedfordshire, William Smith worked for the Duke of Bedford, transforming boggy ground into water meadows.

The Agricultural Revolution saw English wetlands turned into productive fields and pastures. As agricultural prices rose dramatically during the Napoleonic Wars of 1793-1815, ever-more landowners and farmers invested in catchworks and bedworks, and as the 19th century progressed they became fashionable as an agricultural 'improvement'. Some landowners offered prizes for their creation and provided raw materials to encourage tenants to construct them. Through the later 18th and 19th centuries their construction was promoted by agricultural improvers such as George Boswell (*A Treatise on Watering Meadows* 1779), Thomas Wright (*An Account of the Advantages of Watering Meadows by Art*, 1789), William Smith (*Observations on the Utility, Form and Management of Water Meadows and the Drowning of Peat Bogs with an account of Prisleys Bog*, 1806), James Loch (*An Account of the Improvements on the Estates of the Marquis of Stafford*, 1820), via papers in the *Royal Agricultural Society of England's Journal* and through various county surveys or 'General Views' produced for the newly-created Board of Agriculture during the 1790s and early 1800s (Fig 2). By 1850 water meadows in southern England extended to approximately 100,000 acres.

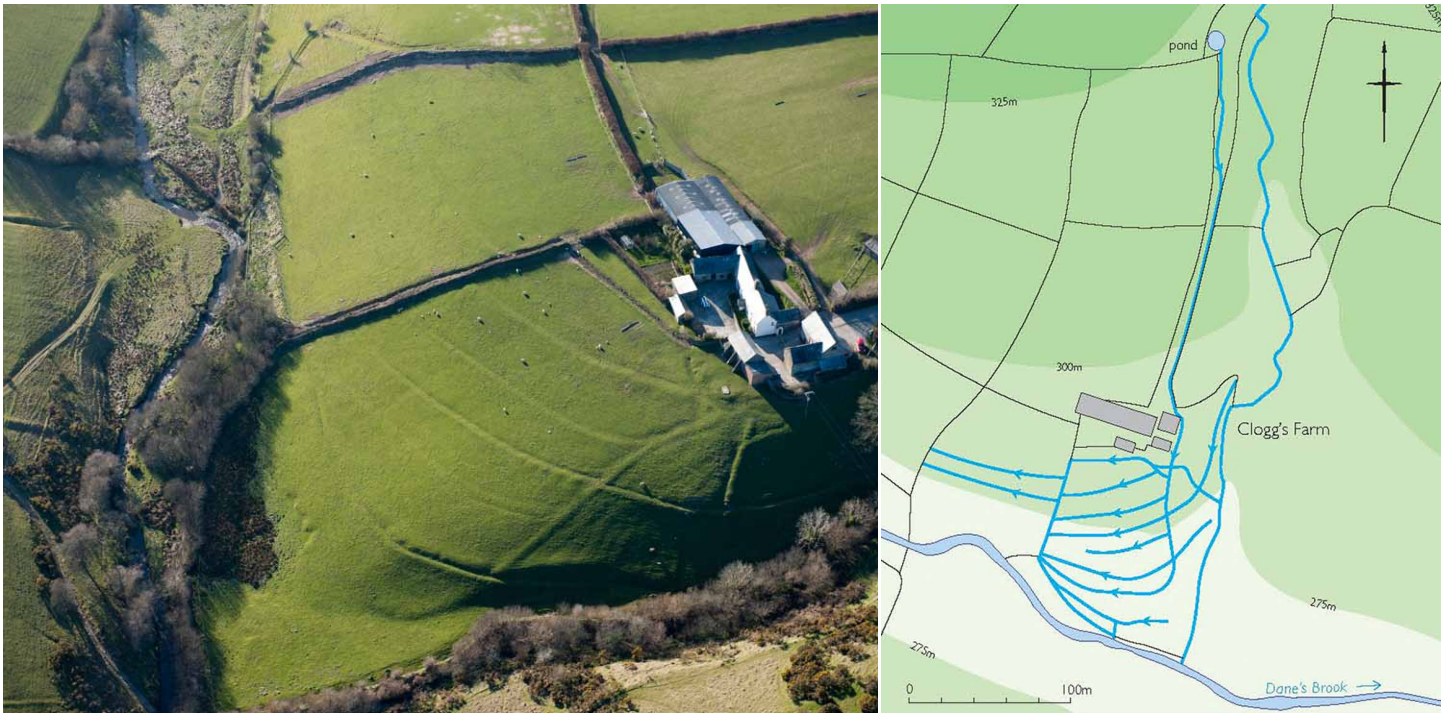
Fig 3: Catchwork meadows are evident today as parallel contour-following channels ('field gutters') on hill slopes, as seen here at Cloggs Farm, Somerset.

Fig 4 (above right): At Cloggs Farm water from a pond flowed into a leat which passed through the farm complex, driving a water wheel. This powered a threshing machine, a

grinder, a chaff cutter, a shearing machine and a wood saw. The leat then passed through the farmyard, collecting slurry which it transported to the meadows via the 'field gutters' on the valley side to the south. Water was collected at the foot of the hill and drained back to a brook. The exact date of construction of this system is not known, but it may be contemporary with the farmstead which dates from at least 1688.

The simplest form of downward floated water meadow is the catchwork (also known as a 'catch meadow' or 'field gutter' system). Catchworks used spring water or hill-side streams to irrigate valley or hill slopes. If neither of these water sources was available rainwater and farmyard run-off was collected in a specially-constructed feeder pond. Water was diverted from the source into a contour-following ditch or 'gutter' which skirted the top of the meadow. When the gutter was blocked by 'stops' of turf, peat or logs, or systems of sluices and boards, water over-flowed down the hillside and irrigated the area of meadow below it. Further down slope further gutters, parallel to the first, caught the water and redistributed it in a similar manner to lower pastures. The process encouraged an even flow of water down the slope. At the base of the meadow the water was collected and carried away via a drain (Figs 3 and 4).

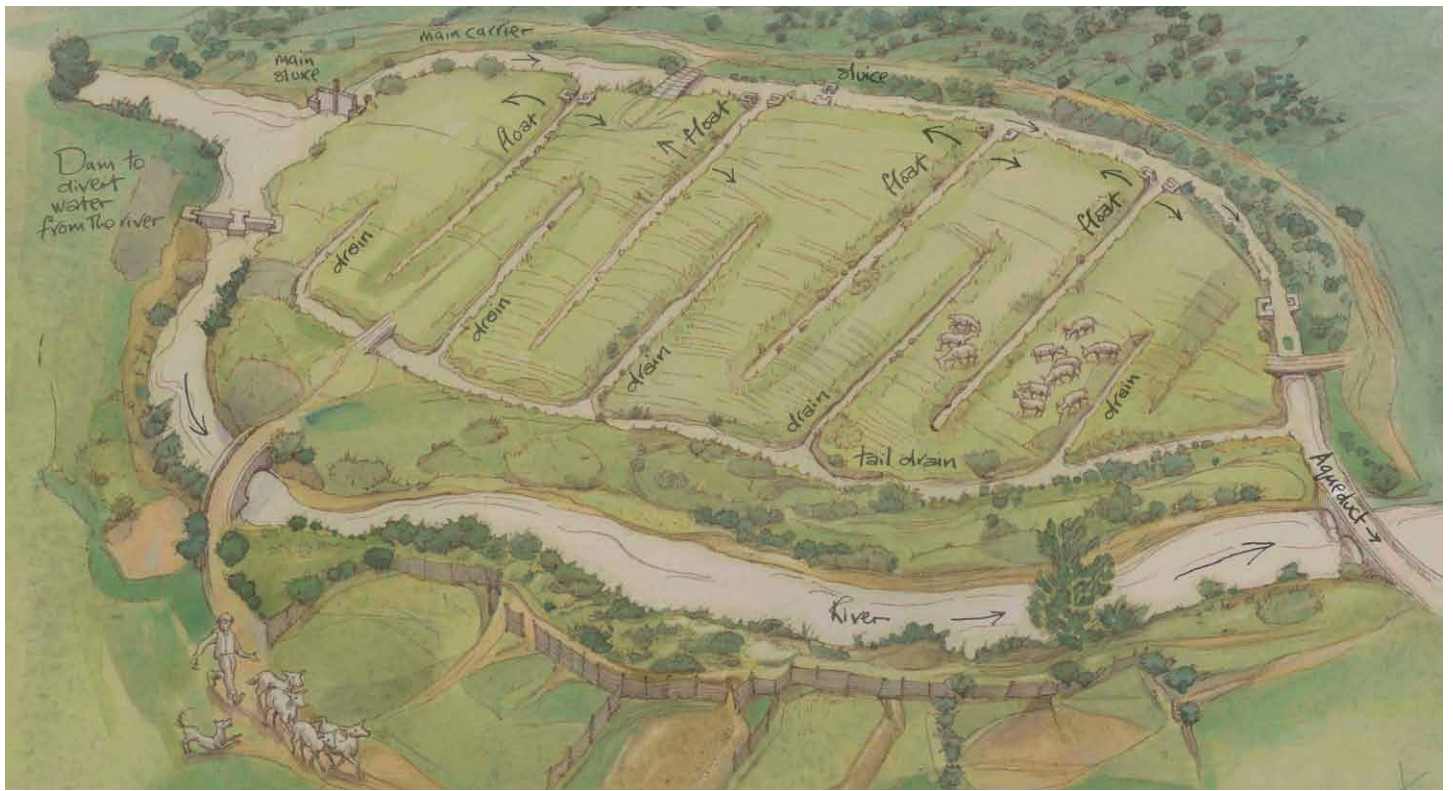
Fig 5. Reconstruction drawing showing a typical bedwork water meadow.

Bedworks were used to irrigate the level ground of river floodplains. A weir or dam containing sluices was placed across the river, often at a bend, allowing water to be diverted into a carrier channel known as a 'head main', which was frequently sited on the outside of the bend. A hatch was opened to let water into the head main, from which it flowed into a network of progressively narrower and shallower carrier channels aligned with the gradient of the meadow. Water was admitted to selected areas of the meadow through subsidiary hatches and was held up when necessary by the use of turf 'stops'. It eventually entered tapering channels known as 'floats', situated along the apexes of parallel ridges known as 'beds'. The water was made to overflow from the floats onto each part of the meadow in succession, running down the sides of the ridges (called 'panes') as a continuous moving film no more than 25mm deep. Run-off was removed from the meadow via a network of drains between the ridges. The drains mirror the arrangement of the mains and floats, beginning as small gullies and becoming progressively

larger as they lead to a single 'tail drain'. In plan bedworks appear as prominent ridges with interlocking channels in the furrow bottoms and, where still visible, along their apexes. The widths and heights of the ridges range from 3-15m (commonly 5m) wide and about 0.5-0.6m high. Bedworks can resemble blocks of ridge-and-furrow ploughing, but their riverine location, their layout and the presence of water control structures all help to distinguish them from former arable (Fig 5).

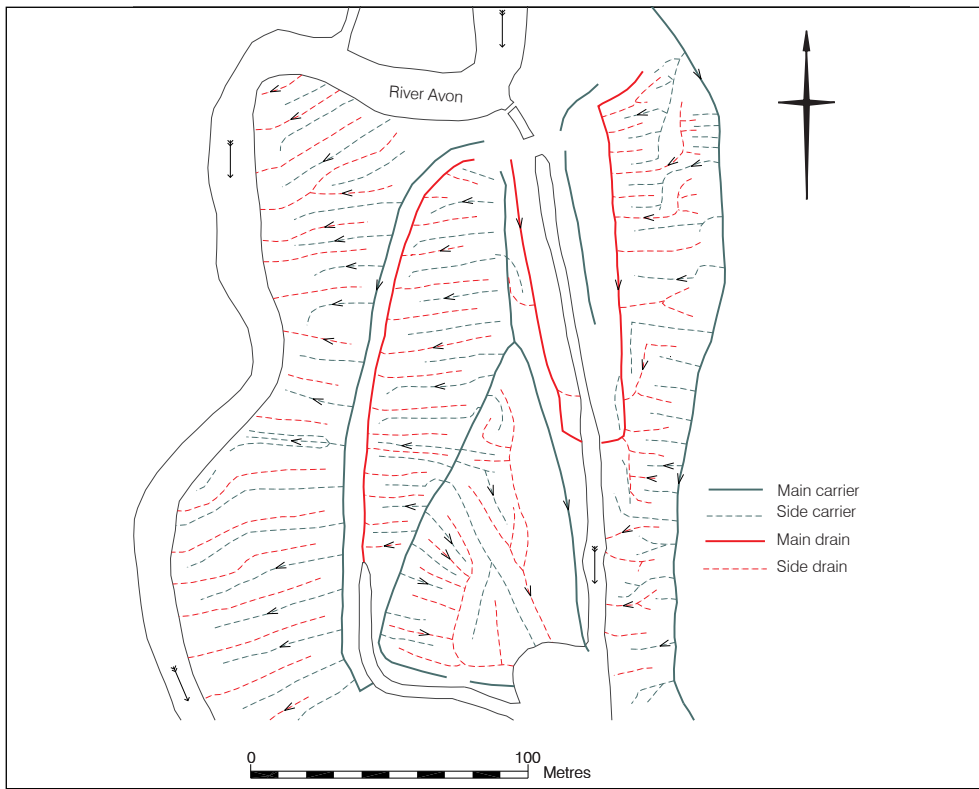
Fig 6. RCHME survey showing a bedwork layout of curved ridges perpendicular to a main carrier at Hindurrington, Wiltshire.

Very little research has been carried out to establish a typology of water meadows, but field surveys of water meadows can shed light on their regional development. Work in Wiltshire by the Royal Commission on the Historical Monuments of England (RCHME) identified two main bedwork layouts: right-angled (Fig 6) or herringbone (Fig 7). Some systems were also highly geometric with all the ridges straight, while others were irregular with curved ridges. The less regular systems may be considerably earlier than the regular examples.

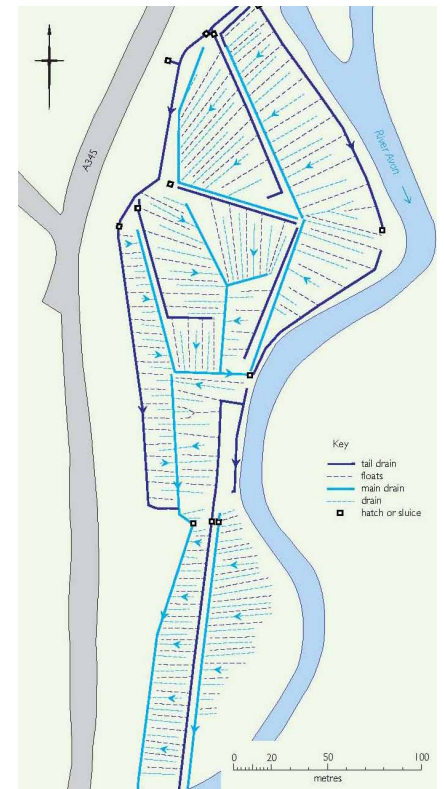
Fig 7. A herringbone bedwork layout, using straight ridges, surveyed by the RCHME at Compton, Wiltshire.

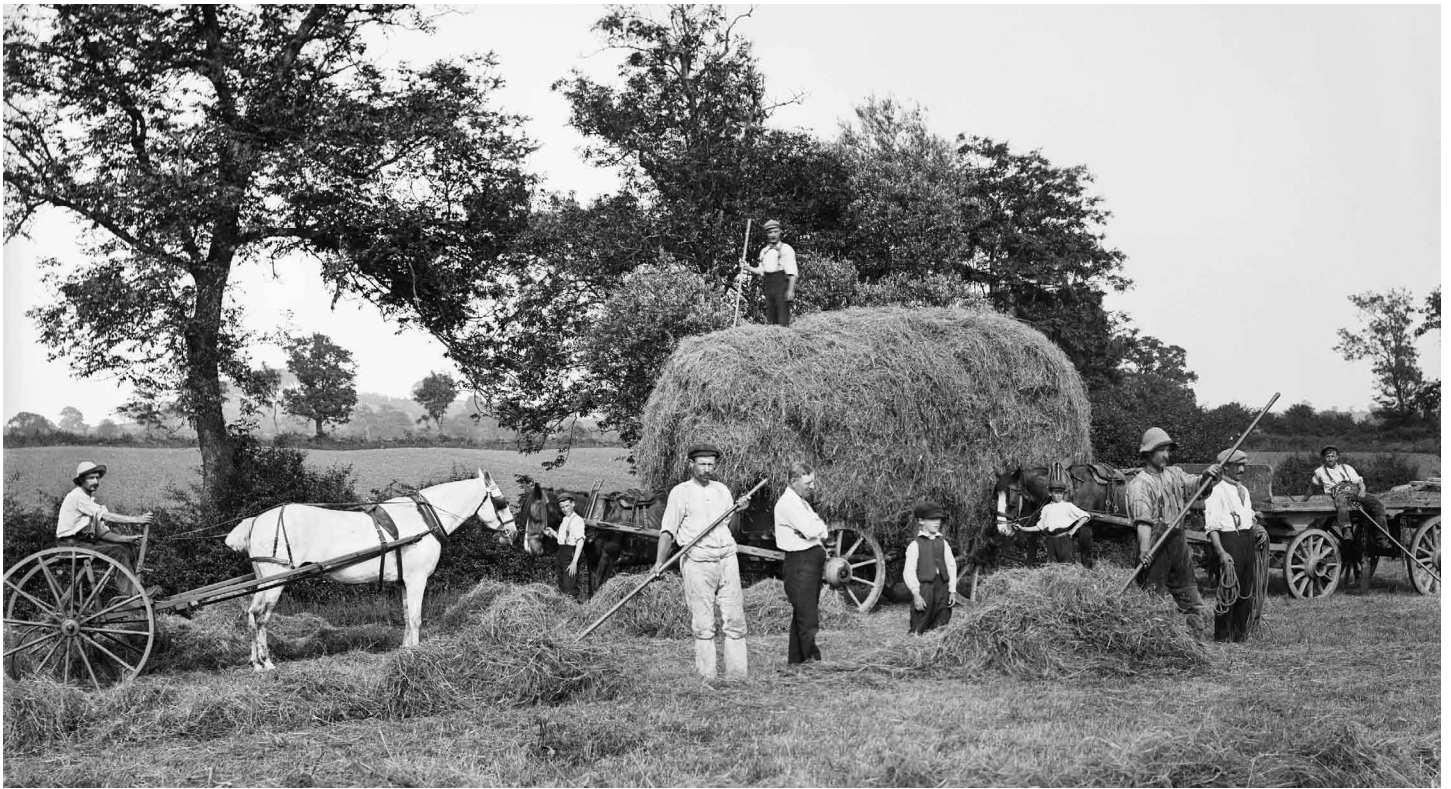
Fig 8. Haymaking at Byfield (Northamptonshire) around the time of the First World War. The dried hay, lying in windrows, is being loaded onto wagons; one has an almost full load; the next waits to the right. On the left is a horse-drawn hay rake, used to scrape up the scattered remnants of the valuable crop.

Working in a line, haymakers moved methodically across the meadow, cutting the lush grass with long-bladed scythes, which would be kept razor-shape with whetstones. This process left the cut grass in lines, and women and children would use pitchforks and rakes to turn and fluff the grass in these 'windrows' to speed even drying. Typically this would take a couple of days, and overnight the hay would be raked into heaps – haycocks – to minimise any damage by rain or heavy dew. In the morning the cocks would be opened up, and the turning resumed (Fig 8).

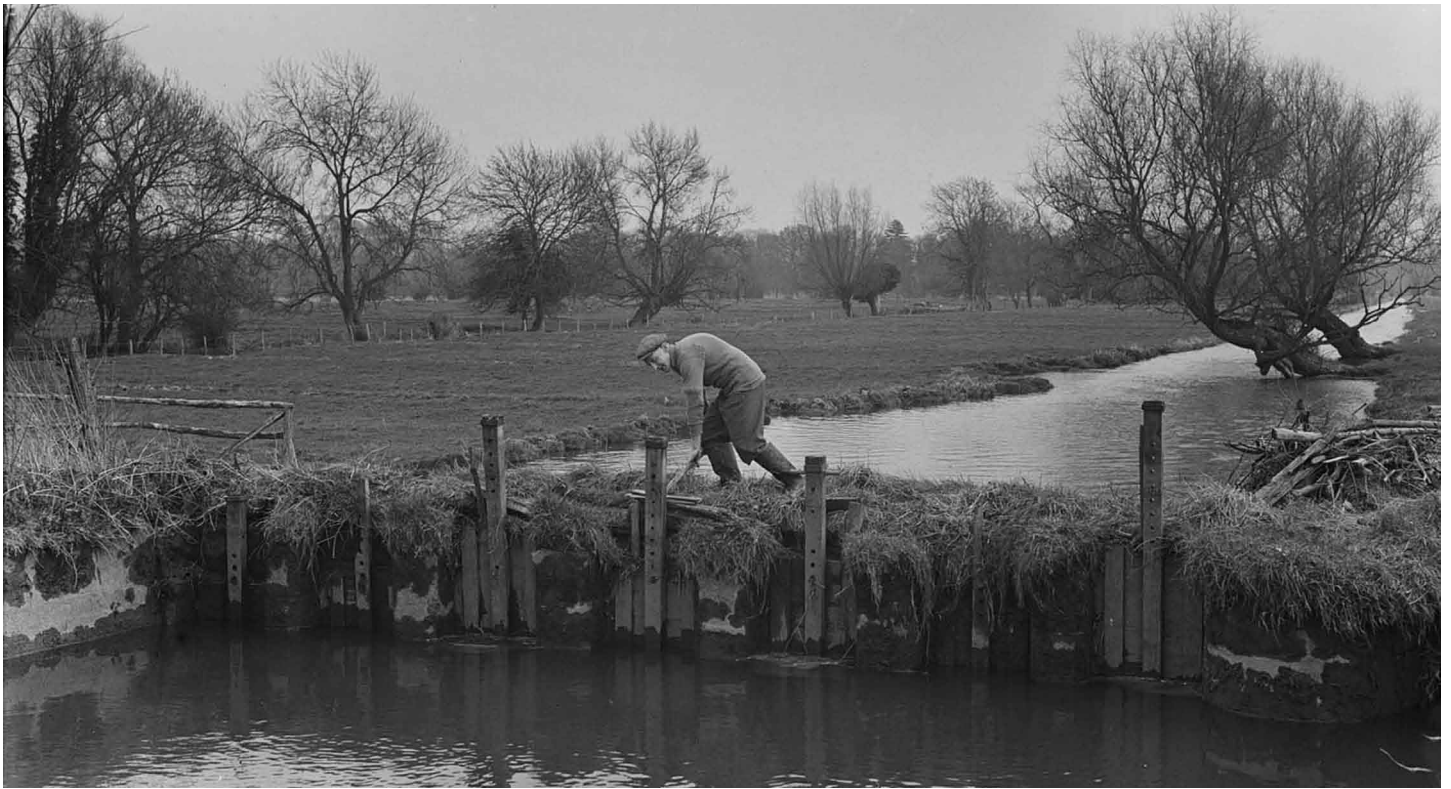
Fig 9. A drowner at work on a seven-hatch weir at Lower Farm, Britford, near Salisbury, in 1954.

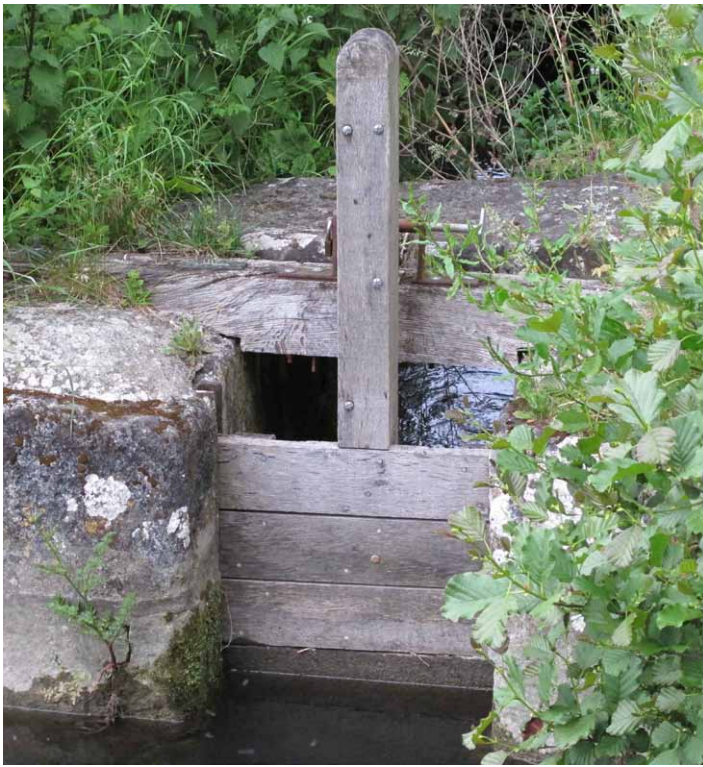
Fig 10. A restored water meadow hatch in use today at Harnham, Wiltshire.

Built structures are also common features of water meadows. A main weir with hatches was built across a river to divert water into the head main of bedwork systems, while subsidiary weirs and sluices (one-hatch weirs) were set up on the smaller carriers to ensure an even distribution of water. Early hatches were simple boards which slotted vertically into wooden frames or stone settings and were raised by peg and hole arrangements (Fig 9). Later, materials such as brick and cement were used for hatch settings and their boards were fitted with iron ratchet and crowbar raising mechanisms. At the beginning of the 19th century cast iron weirs and hatches came into use. Bridges and culverts were used to provide access across the water meadow channels, and aqueducts sometimes took water to further areas of meadow. Water meadow structures may therefore be made from stone, wood, brick, concrete or metal,

depending on what was readily available at the time of their construction (Fig 10). Collections of loose material near the banks of rivers or streams may indicate the presence of buried structures or the positions of former structures.

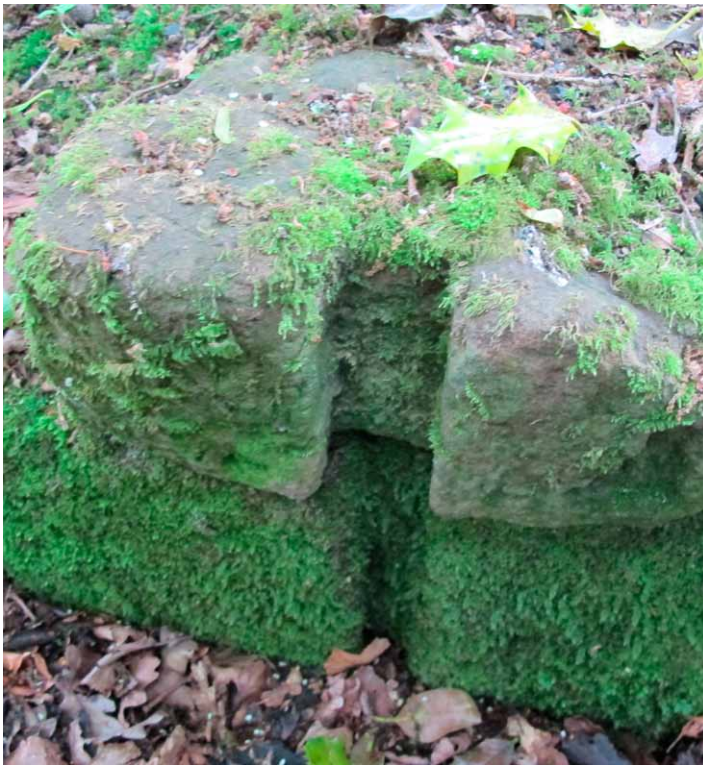
Fig 12. Slotted stones are often all that remains of water meadow sluices. They are difficult to date without evidence from other sources, though later sluices were often brick-built.

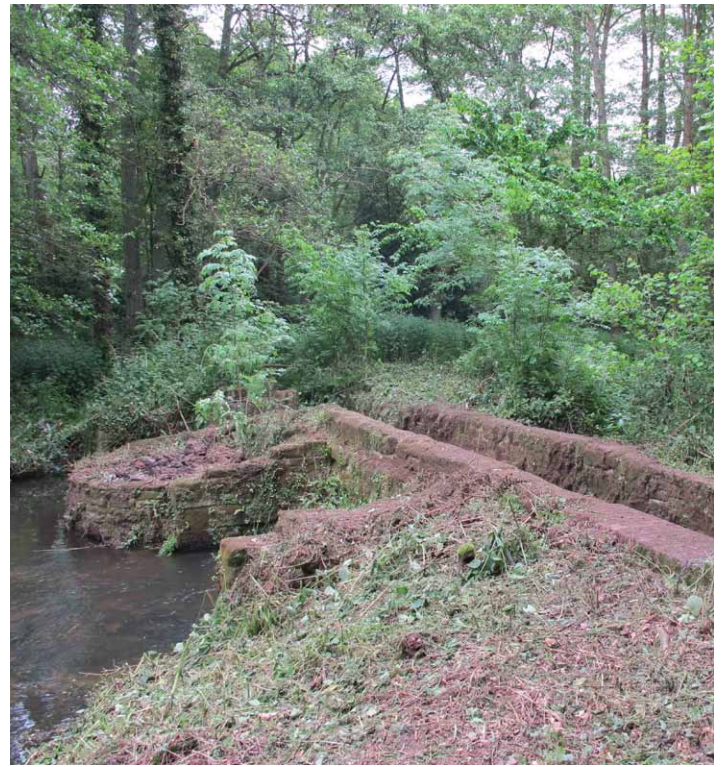
Fig 13. Aqueducts carried water through narrow sections of the Wey Valley, allowing its water meadow systems to function in difficult topography. This example at Bramshott Court is one of several built to connect water meadows on either side of the river.

to difficult topography, such as the narrow upper valley of the River Wey in Hampshire, where contour-following carrier channels were used to raise water above the river level, aqueducts by-passed bottlenecks in the valley and both the valley sides and the narrow valley floor were irrigated using combinations of catchworks and bedworks. In addition to
